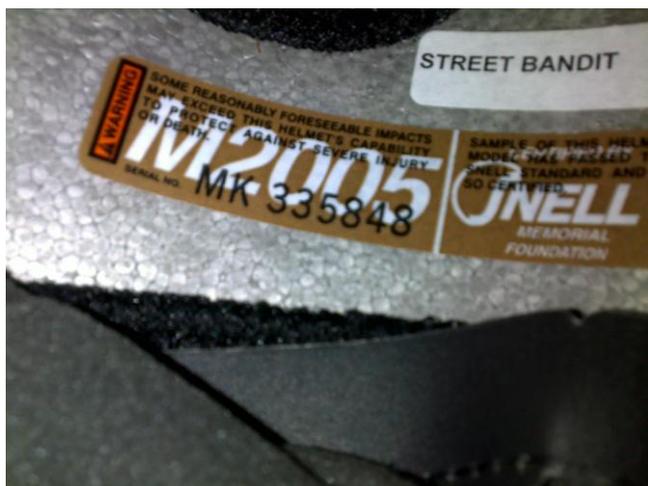
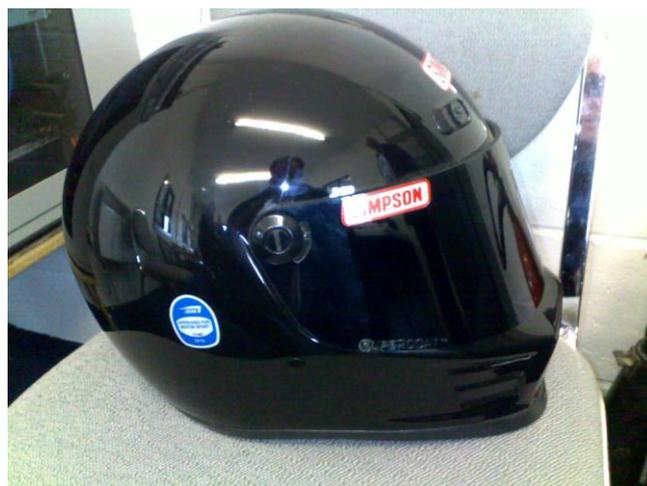
Snell M2005 helmet

The Helmet pictured below was picked up during Scrutineering at a recent event. An MSA-approved Helmet Sticker had previously been applied but, upon inspection, it was found to be a Snell M2005 standard helmet. Please remember that M2005 is a motorcycle standard and is not acceptable under MSA Regulations. Acceptable Snell standards will be prefixed SA (or K, CMR or CMS for Kart Specific helmets) and be printed on an orange label (Blue, Red or Grey for Kart), not the bronze/brown label as shown below.

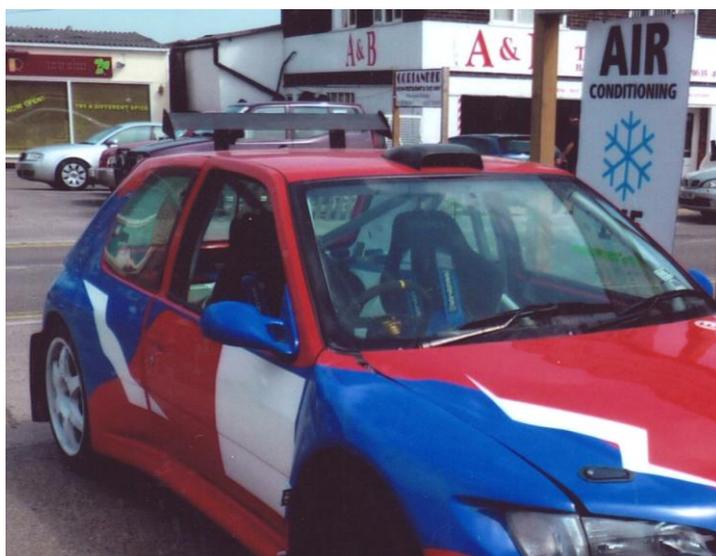
Stage Rally Car Rear Wings

We continue regularly to come across vehicles in Stage Rallying – particularly on log book applications – fitted with rear aerodynamic devices that do not comply with (J)5.2.7. The Regulation states that they may only be fitted if they are FIA homologated or in compliance with national type approval. Remember that this refers to genuine parts, not replicas or copies.

The example to the right is a car that recently came in for log-booking; checks revealed that the design did not match that appearing on the homologation papers.

It is the competitor's responsibility to prove the origins of the part, but you would expect a type-approved manufacturer's part to bear the manufacturer's part number, and a genuine FIA homologated part will have the homologation number stamped into it.

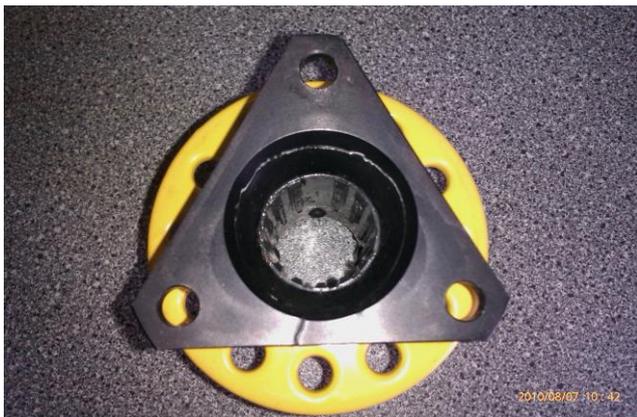
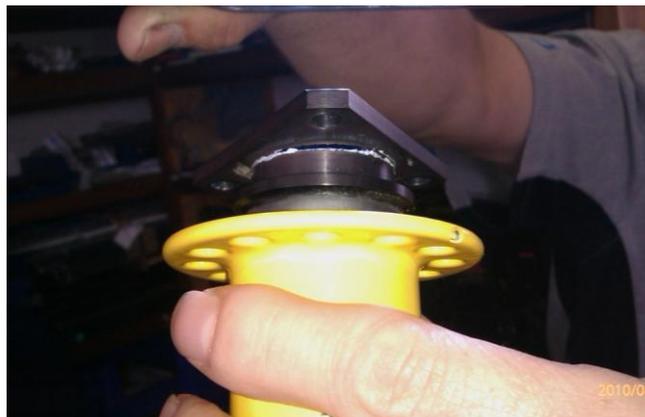
Steering Wheel Quick Release Hubs

We have had reports of steering wheel quick release hubs manufactured by 'Sadev' cracking. This equipment is thought to be fitted to a variety of cars, including some single-make racing car formulas. The crack is propagated in the corner of the flange to which the steering wheel is bolted. Although we understand there has been a product recall, it is worth keeping a wary eye open for such cracking, irrespective of the identity of the manufacturer.
